111 Condo Circle

PROPERTY INSPECTION REPORT

Concerning: 111 Condo Circle
(Address or Other Identification of Inspected Property)

By: Frank Schulte-Ladbeck TREC# 9073 11/11/2011
(Name and License Number of Inspector) (Date)

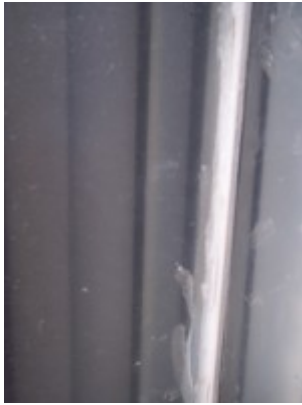
Glazing strips missing from both windows. Window panes damaged, with one having a hole in it. Rear bedroom window is screwed shut. Window in front bedroom not working well.

Window glazing strip missing.

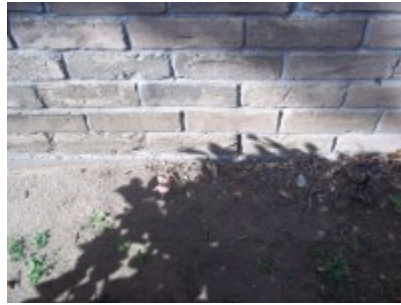
The grading is high on the foundation. Having six inches would help prevent moisture and pest problems.

Grading high on foundation.

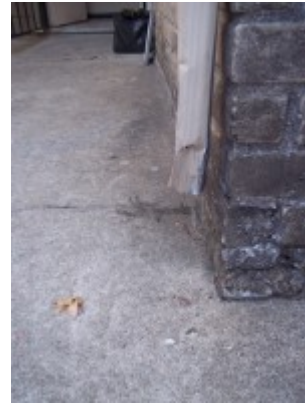
Condition of the gutter system: gutter downspout damaged by entrance

Downspout dumping water down on path.

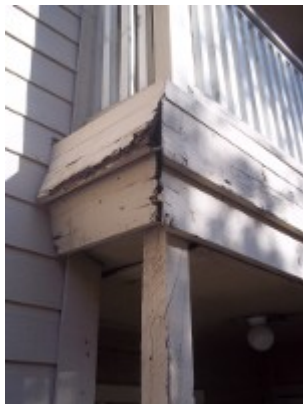
Trim from the porch above, which makes a roof for this unit had major moisture damage
The roof over the porch had moisture damage.

.Moisture damage porch area.

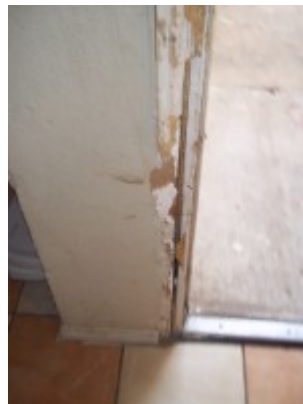
There was missing door trim or damaged door trim in the unit.

Missing trim front door.

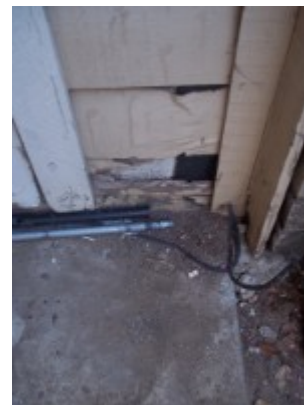
Exterior cladding on porch is missing in spots and damaged in others.

Damage to wall cladding in porch area.

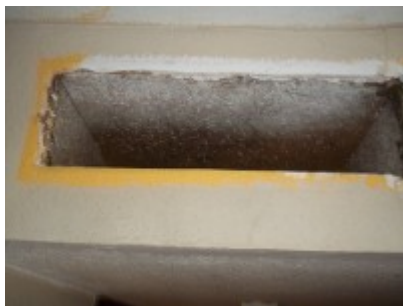
The register (vent) in the den did not have a cover.

Missing vent cover.

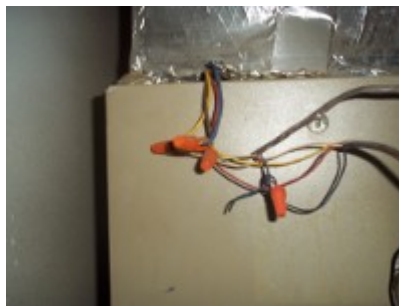
Wiring connections for air conditioning system should be inside unit to protect them.

Wiring connection not in unit.

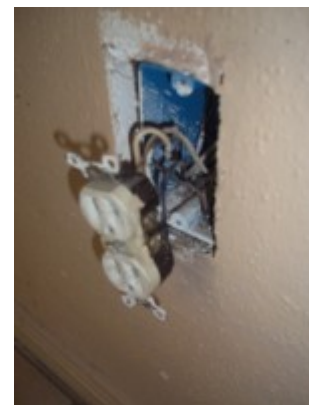
Switches and other outlet issues: two outlets not attached to the junction box: one is above the microwave; the other is in the front bedroom.

Outlet not attached.

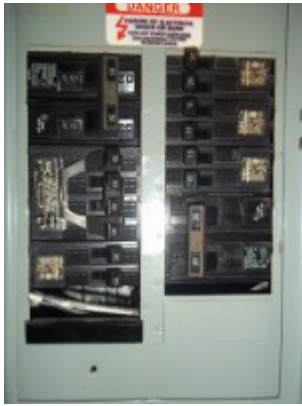
There should be no gaps.

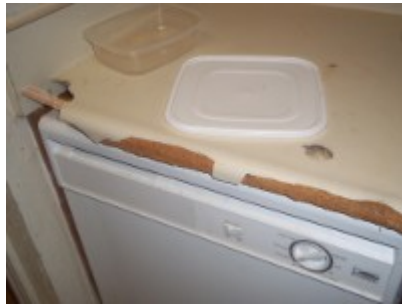
Lower kitchen cabinets and counters are damaged as is the bathroom cabinets.

Cabinet busted in kitchen.

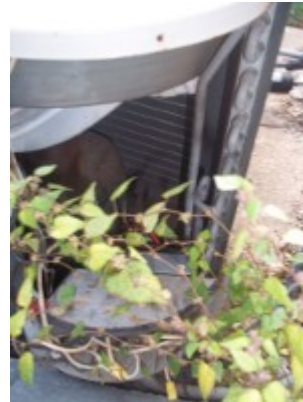
Compressor did not work. The panel covering the internal wiring was replaced with a piece of sheet metal that was not on.

Compressor taken apart.

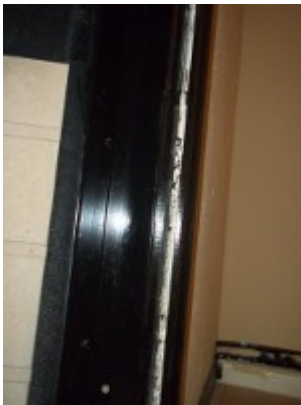
Minor creosote in flue. The unit was set back from the wall causing a gap.

Gap by fireplace to the wall.

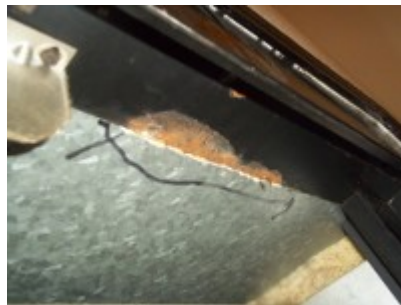
Rust signs in firebox indicate past leak. Damper was hard to open.

Rust signs in firebox of fireplace.

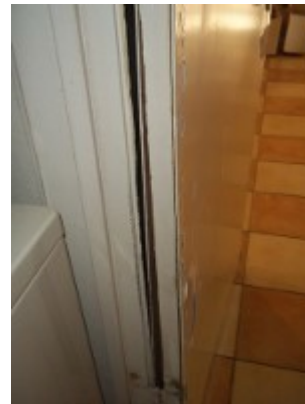
The utility closet door is damaged.

Damage to utility closet door.

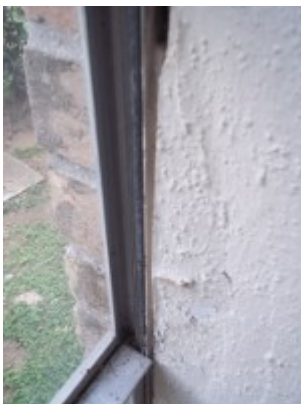
Past moisture damage signs around the interior of both windows.

Moisture damage to wall in window area.
