111 Condo Circle

PROPERTY INSPECTION REPORT

Concerning: 111 Condo Circle
(Address or Other Identification of Inspected Property)

By: Frank Schulte-Ladbeck TREC# 9073 11/11/2011
(Name and License Number of Inspector) (Date)

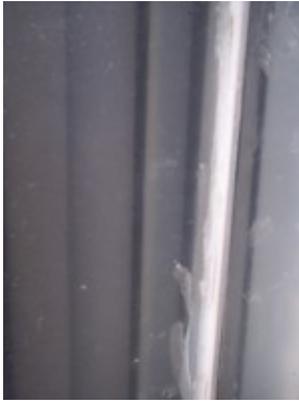
Glazing strips missing from both windows. Window panes damaged, with one having a hole in it. Rear bedroom window is screwed shut. Window in front bedroom not working well.

Window glazing strip missing.

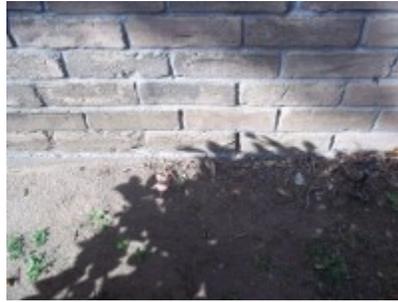
The grading is high on the foundation. Having six inches would help prevent moisture and pest problems.

Grading high on foundation.

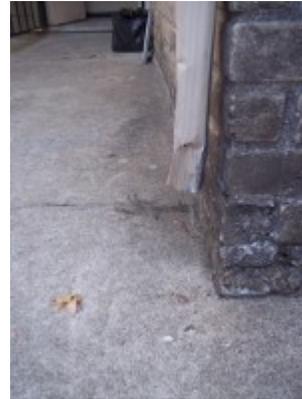
Condition of the gutter system: gutter downspout damaged by entrance

Downspout dumping water down on path.

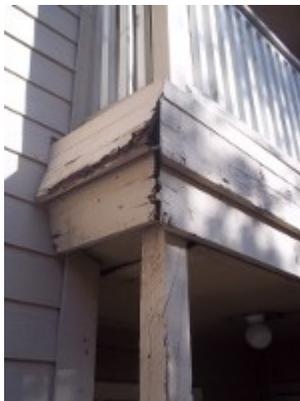
Trim from the porch above, which makes a roof for this unit had major moisture damage
The roof over the porch had moisture damage.

.Moisture damage porch area.

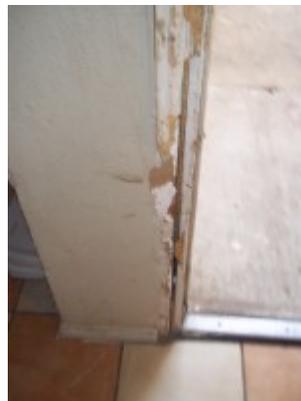
There was missing door trim or damaged door trim in the unit.

Missing trim front door.

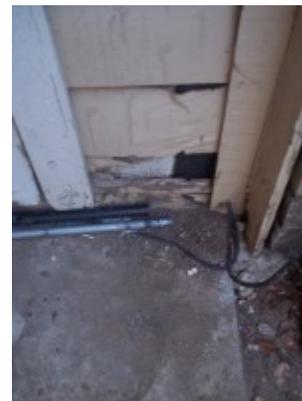
Exterior cladding on porch is missing in spots and damaged in others.

Damage to wall cladding in porch area.

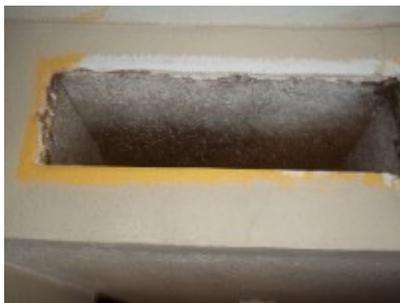
The register (vent) in the den did not have a cover.

Missing vent cover.

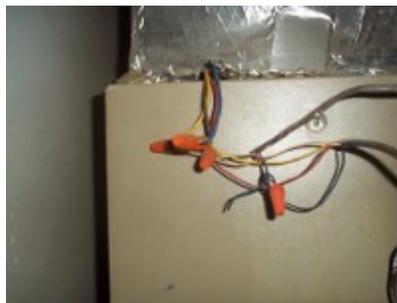
Wiring connections for air conditioning system should be inside unit to protect them.

Wiring connection not in unit.

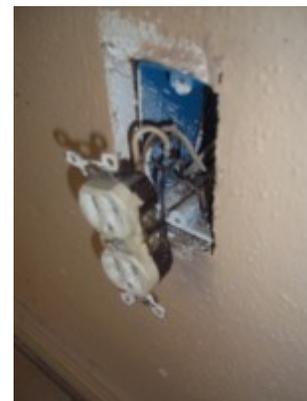
Switches and other outlet issues: two outlets not attached to the junction box: one is above the microwave; the other is in the front bedroom.

Outlet not attached.

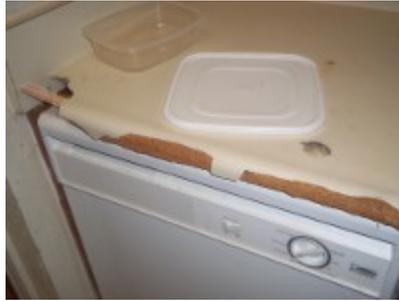
Lower kitchen cabinets and counters are damaged as is the bathroom cabinets.

Cabinet busted in kitchen.

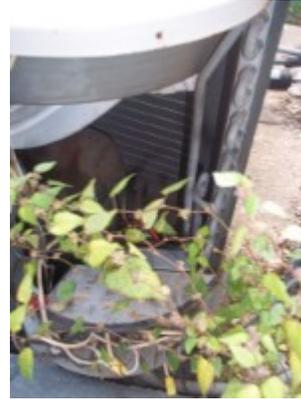
Compressor did not work. The panel covering the internal wiring was replaced with a piece of sheet metal that was not on.

Compressor taken apart.

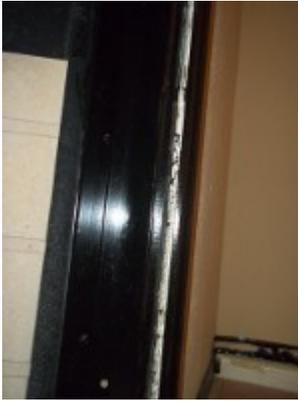
Minor creosote in flue. The unit was set back from the wall causing a gap.

Gap by fireplace to the wall.

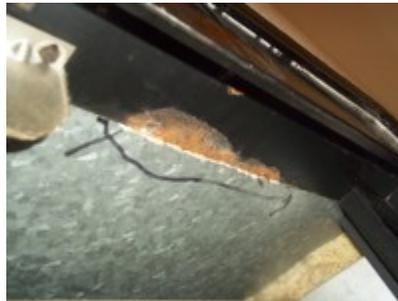
Rust signs in firebox indicate past leak. Damper was hard to open.

Rust signs in firebox of fireplace.

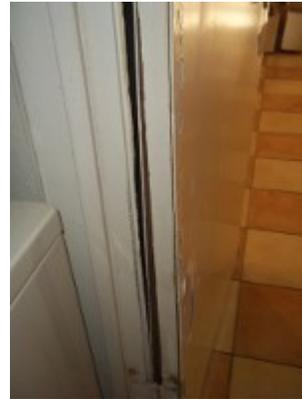
The utility closet door is damaged.

Damage to utility closet door.

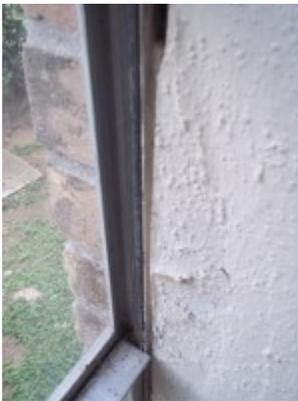
Past moisture damage signs around the interior of both windows.

Moisture damage to wall in window area.
