111 Foreclosure Lane

Property Inspection Report

Concerning: 111 Foreclosure Lane
(Address or Other Identification of Inspected Property)

By: Frank Schulte-Ladbeck TREC# 9073 11/11/2011 and 12/12/2011
(Name and License Number of Inspector) (Date)

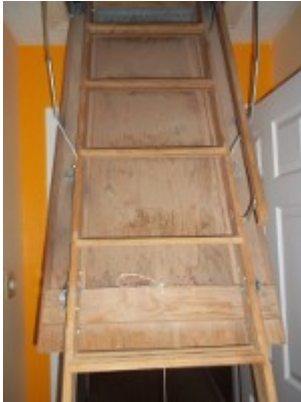
The main attic has a ceiling entry in the right front upstairs bedroom. This entry was not seating well in the frame (gaps), and the door had no insulation or weatherstripping.

No insulation on door.

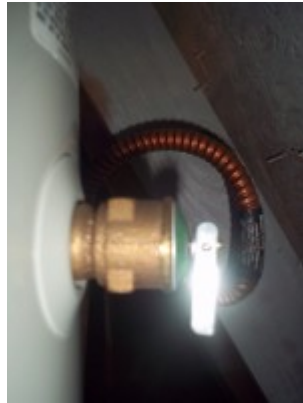
TPR valve line going up.

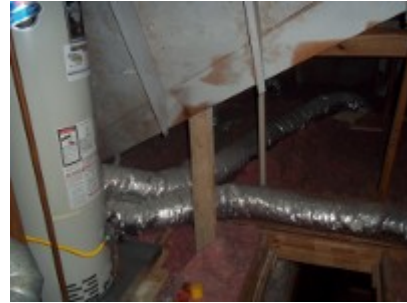
Workspace for water heater lacking ducts on insulation.

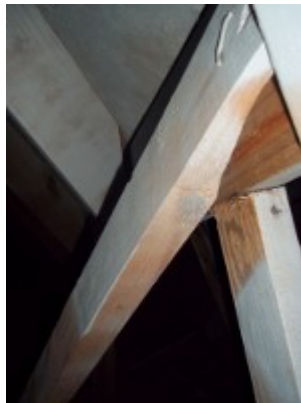
Condition/Description: There are signs that a fire had occurred in the attic, but I did not find any damage. There was a loose brace by the heater further away from the entry under the flat roof which was not attached.

Brace not attached.

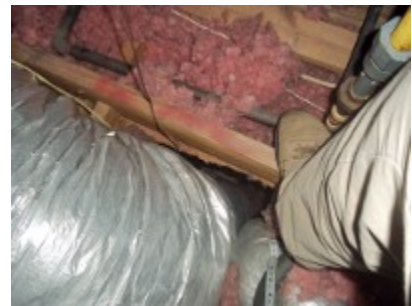
There are places where the ducts go down into the living space These shafts are not insulated. The best solution is to place batt insulation over these holes.

Duct shaft should have insulation over it.

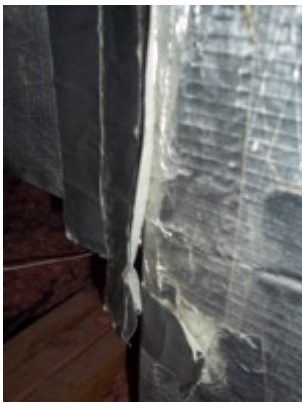
Plenum improperly sealed.

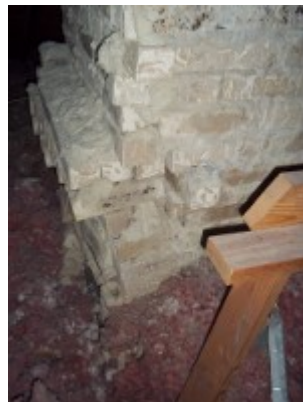
The movement in the home has caused damage to the brick sealing the chimney in the attic. There are gaps in the chimney, and there could be possible damage to the flue. I would advise having this examined further by a qualified professional.

Chimney has gaps in attic.

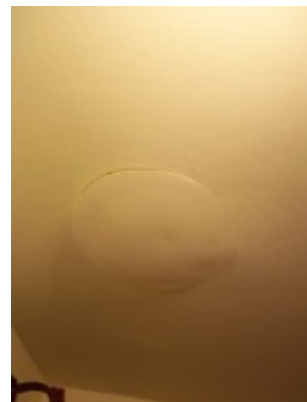
Bad patch in ceiling of Master bedroom closet.

Bad patch in Master bath closet.

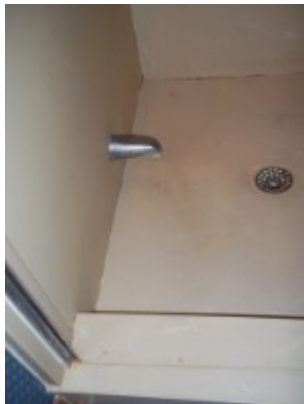
Faucet too low.

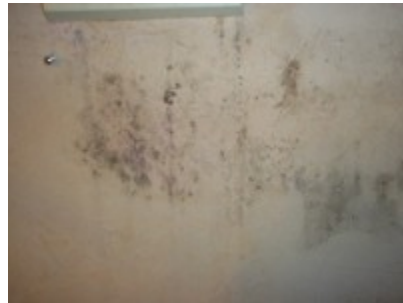
Mold testing is not part of this inspection, but there was a substance which appeared to be dead mold in one location: rear left room. Mold needs a moist environment to live. A proper mold test is conducted by sending a sample to a laboratory.

Possible mold.

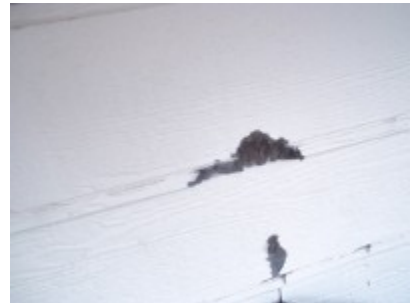
Wall board damage.

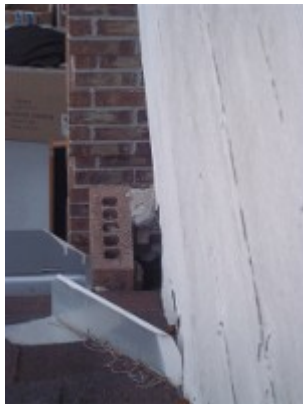
The tops of the columns near the garage are open at the top, allowing water in.

Columns open at top allow water entry.

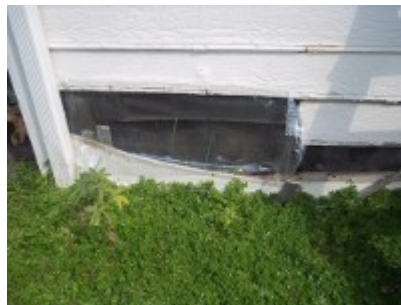
The garage wall is missing clapboards.

Missing wall boards.
