111 Foreclosure Lane

Property Inspection Report

PROPERTY INSPECTION REPORT

Concerning: 111 Foreclosure Lane
(Address or Other Identification of Inspected Property)

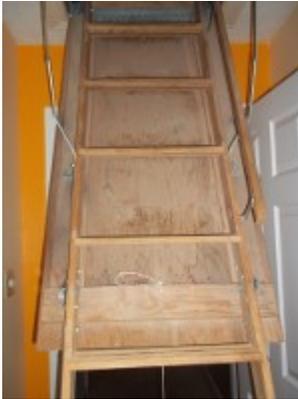
The main attic has a ceiling entry in the right front upstairs bedroom. This entry was not seating well in the frame (gaps), and the door had no insulation or weatherstripping.

No insulation on door.

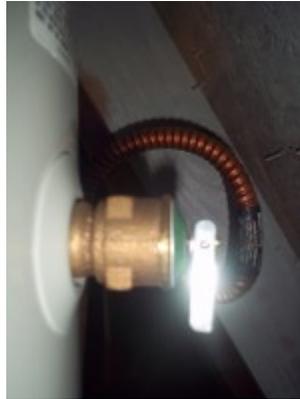
TPR valve line going up.

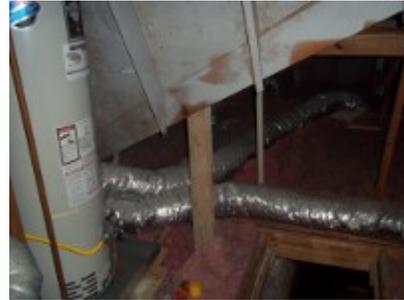
Workman for the equipment should have a landing , a walkway, and adequate workspace in front of the equipment with lights. There is a walkway between the two units, but you would have to go around on th framing to reach the walkways. The water heater could use better workspace. The first light is on a pull chain. The next light did not have a pull chain, so I screwed it in to obtain light.

Workspace for water heater lacking ducts on insulation.

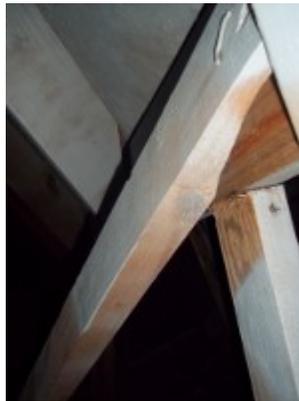
Condition/Description: There are signs that a fire had occurred in the attic, but I did not find any damage. There was a loose brace by the heater further away from the entry under the flat roof which was not attached.

Brace not attached.

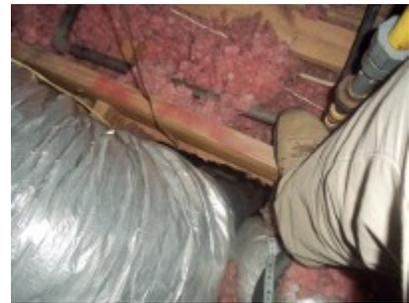
There are places where the ducts go down into the living space These shafts are not insulated. The best solution is to place batt insulation over these holes.

Duct shaft should have insulation over it.

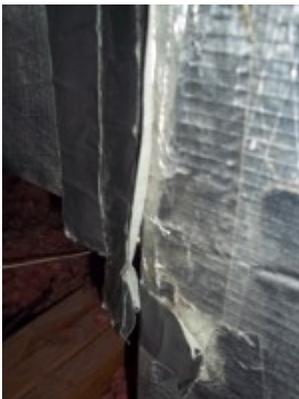
Plenums were not properly taped.
Rust signs in the pans under the evaporator coils.
One compressor was out of level, water does not seem to effect it.
Seal the chase for the exterior unit on the left.

Plenum improperly sealed.

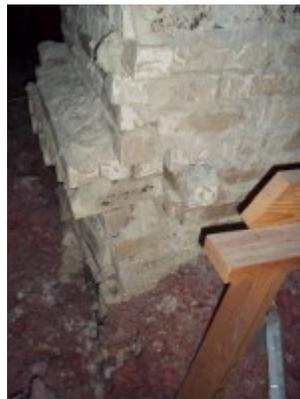
The movement in the home has caused damage to the brick sealing the chimney in the attic. There are gaps in the chimney, and there could be possible damage to the flue. I would advise having this examined further by a qualified professional.

Chimney has gaps in attic.

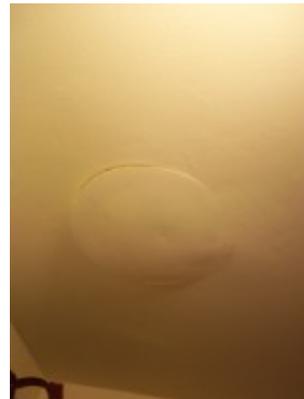
Bad patch in ceiling of Master bedroom closet.

Bad patch in Master bath closet.

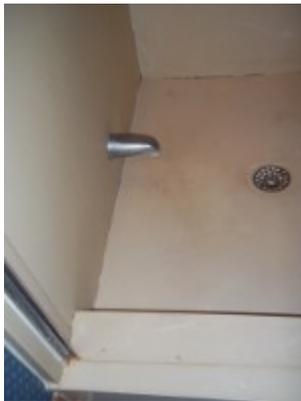
Foot was faucet too low.

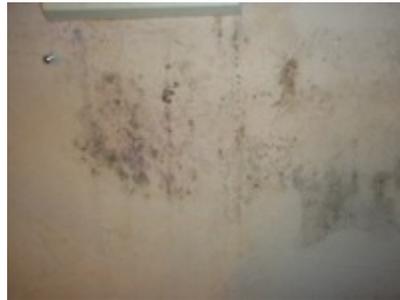
Mold testing is not part of this inspection, but there was a substance which appeared to be dead mold in one location: rear left room. Mold needs a moist environment to live. A proper mold test is conducted by sending a sample to a laboratory.

Possible mold.

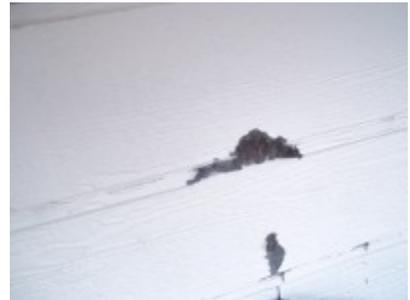
There was moisture damage to clapboards on the second floor, around the home.

Wall board damage.

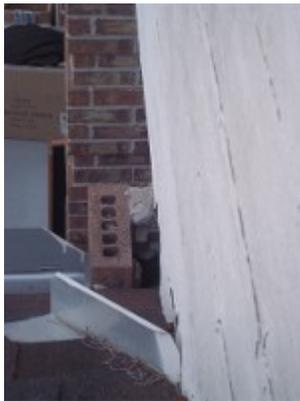
The tops of the columns near the garage are open at the top, allowing water in.

Columns open at top allow water entry.

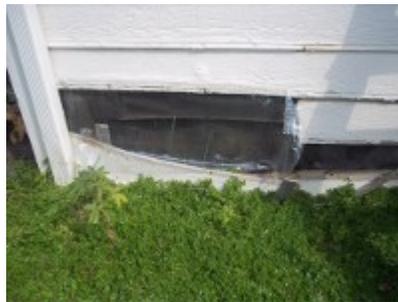
The garage wall is missing clapboards.

Missing wall boards.
