# 111 New Home Way

# PROPERTY INSPECTION REPORT

Concerning: 111 New Home Way  
(Address or Other Identification of Inspected Property)

By: Frank Schulte-Ladbeck TREC# 9073 11/11/2011  
(Name and License Number of Inspector) (Date)

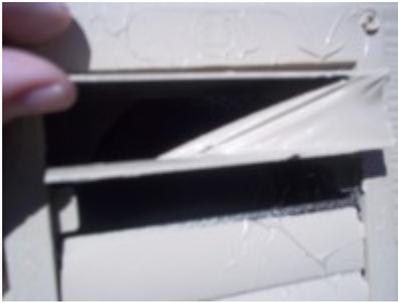
Vent for Master bathroom on right side was painted over in such a way that the louvers were stuck together. The range hood vent was not well painted on the left side of the home, with some spots near it.

Vent painted over, sealing louvers.

**On 12/5:** the vents had been cleaned to allow free movement. There is still a bit of touch up needed on the left side clapboard by vent.

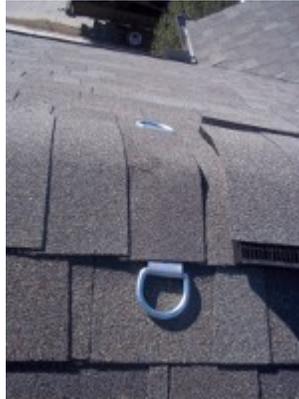
A hook system for working on the roof was left in place on the top ridge.

On 12/5: the hook system appears to be in place still. There is a chance that this could lead to damage. The roof and the flashing over the front porch was addressed.

Hook in top roof ridge.

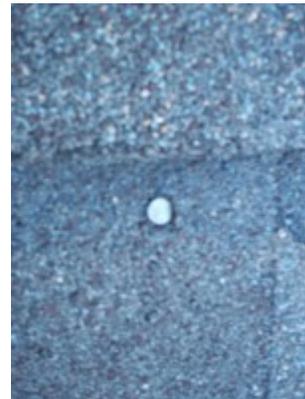
There was an exposed nail that should be caulked below the vent on the roof for the dryer.

Exposed nail below dryer vent.

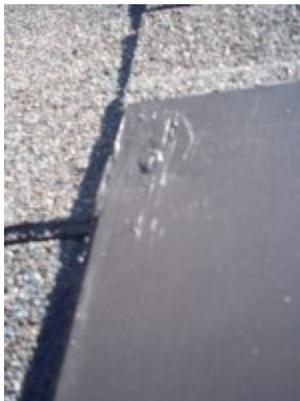
The flashing under the windows of the left front bedroom needs to be repainted.  
. The flashing on the chimney needs better caulk on the nail head.

Nail has caulk, but could be better-chimney flashing.

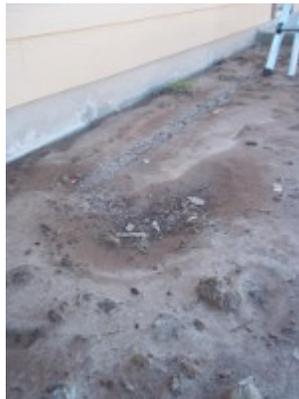
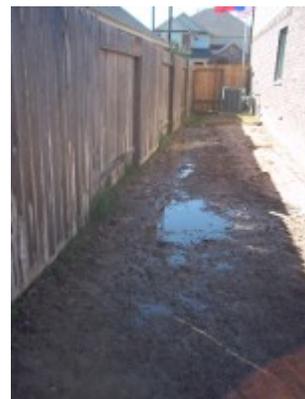
The grading in the rear had the basic grading to divert water to the middle of the yard, and then down to the street. However, this grading was not ready for grass it seemed. Also, the water was still standing on the right side of the home from rain two days ago. The grading allows for water to pool near the Master bedroom bay windows near the rear porch.

On 12/5: some corrections to the grading in the rear were made. There is still a concern with the grading near the Master bed.

Grading allows pooling near Master bedroom and right side of home.

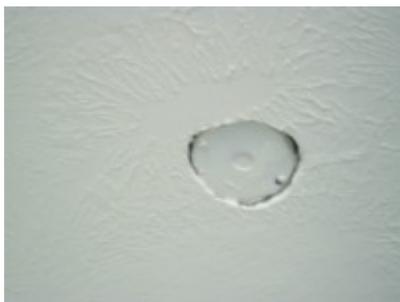
The exposed junction boxes over the kitchen island did not seem right. If no fixtures are being installed at this time, will they have a better cover?

Condition of the fixtures: the kitchen island had three boxes in the ceiling which are intended for lights, but no lights have been installed; the junction boxes do have their covers here.

Ceiling above kitchen island: fixture or cover.

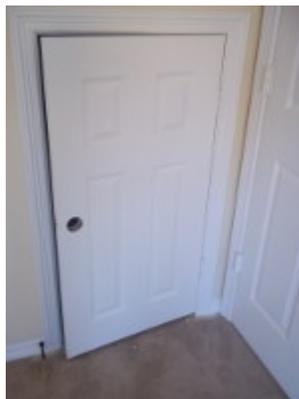
Master bedroom closet under the stairs did not have a door handle or a door stop.

On 12/5: garage door was operable. Door stop was added for Master bedroom, but no handle.

Door without handle and stop in Master bed.

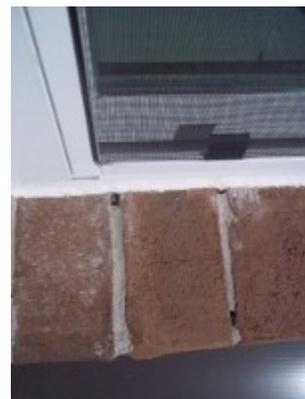
The brick sill in the window above the front entry, second story, had gaps in the mortar that need to be filled to prevent moisture entry.

Gap in brick sill mortar over porch

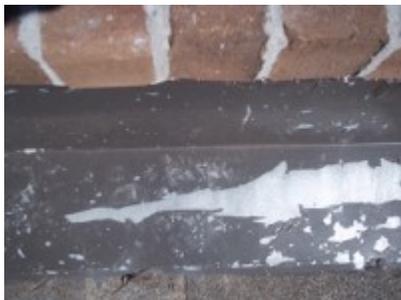
Flashing over porch in need of paint.

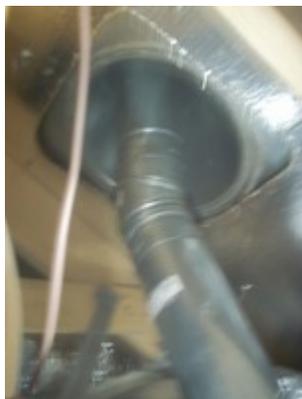
Heater furnace needs to be strapped in.

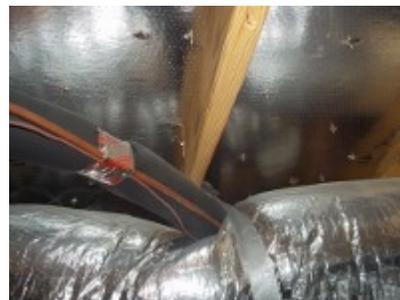
Hot refrigerant line touching duct.

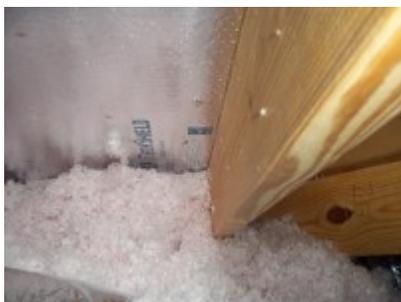
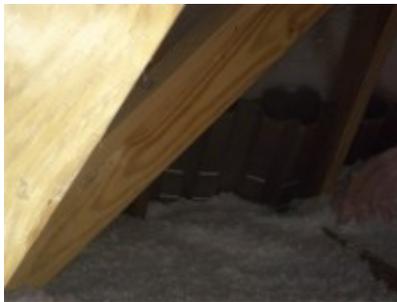
Baffles were in place to allow air movement under the sheathing, but there were a few places where insulation blocked the air flow.

Insulation blocking air movement, but most spaces ave baffle as seen in picture on the right.

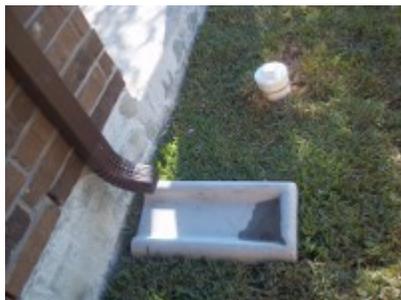
Condition of the gutter system: on the front of the home. The splashguards are turned around the wrong way. They currently hold water, where they should be directing water away from the home.

Splashguards turned around wrong, so they will hold water.
